FATIGUE STRENGTH OF METAL SANDWICH
TYPE CONSTRUCTION.

Thesis by
William E. ^{merson} Lamb

In Partial Fulfillment of the Requirements
For the Degree of
Aeronautical Engineer

1949

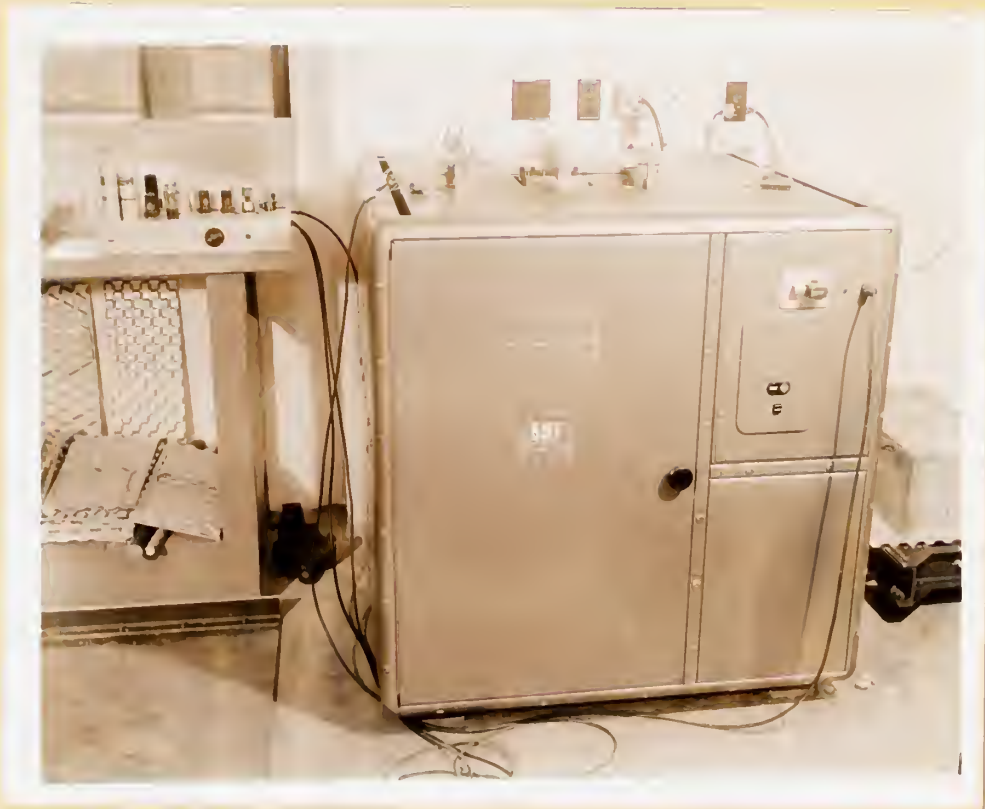
Figure 2

Testing Machine with Electronic Cut-off Circuit

steel rods, that were secured to the stationary part of the testing machine. The specimen's end was squeezed between two of these rods to prevent up or down motion, but to allow some motion along its length. Details of the loading adapter and testing machine set-up may be viewed in Figures 2, 3, and 10.

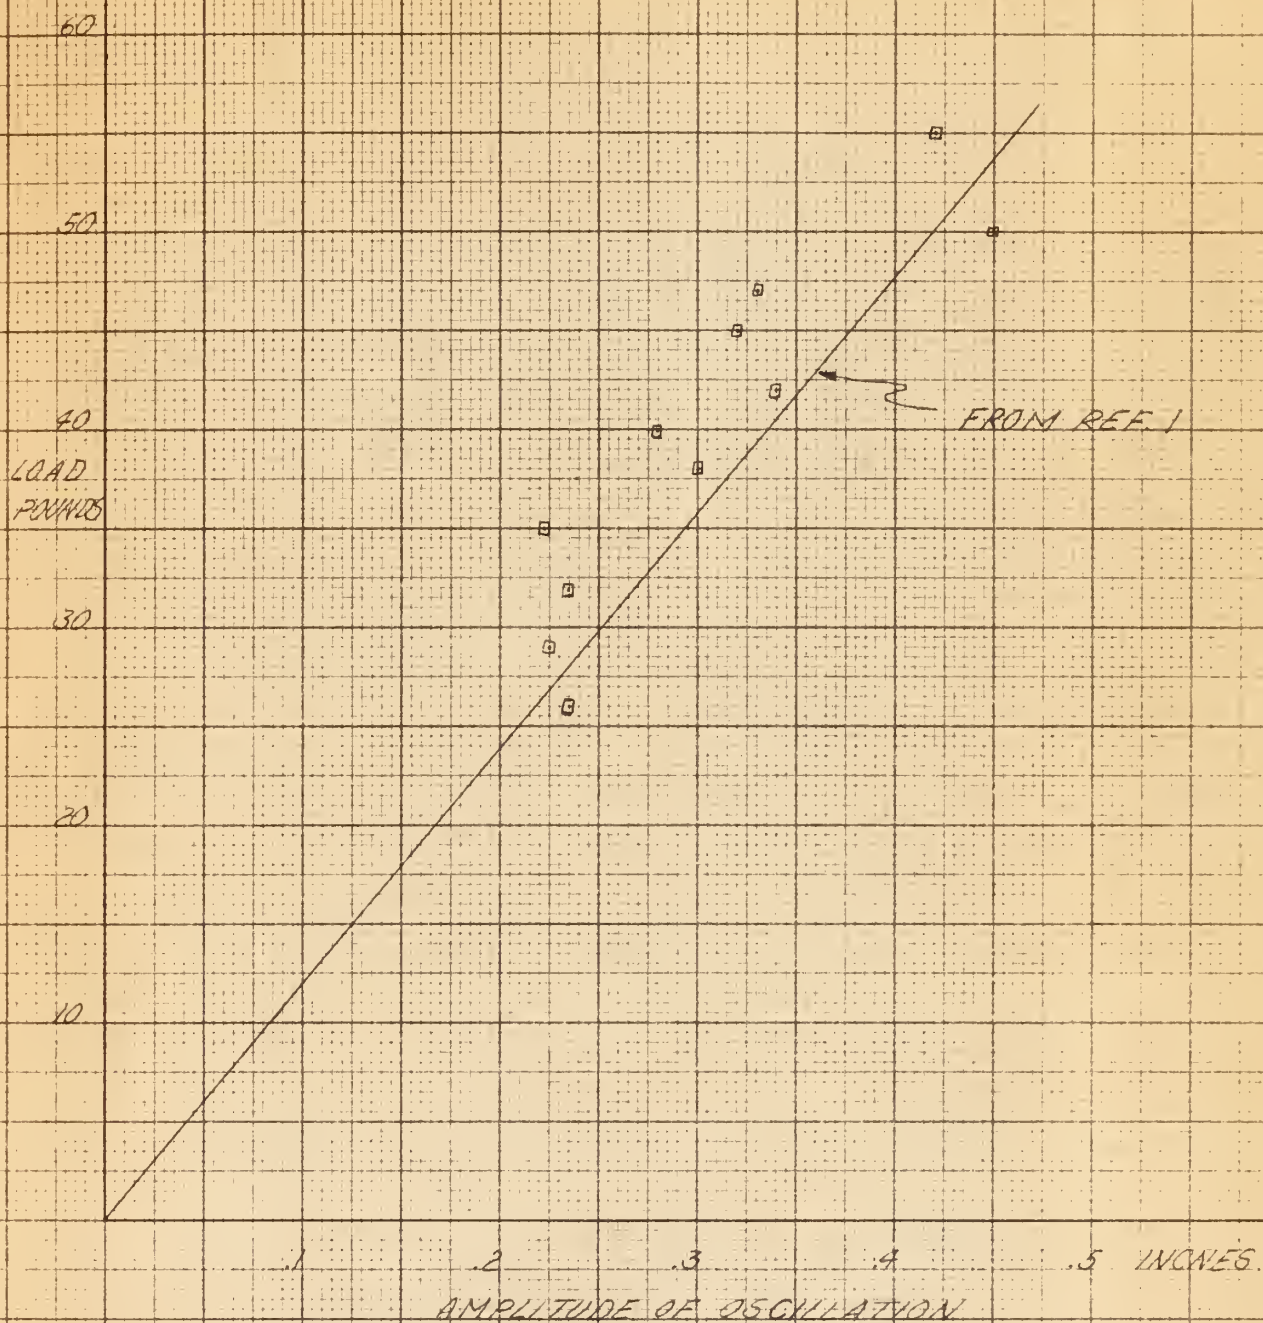
FIG 7
COMPARISON OF AMPLITUDE OF OSCILLATION
WITH STATIC AMPLITUDE COMPUTED USING
EI OF REF. 1
SQUARE PATTERN

Figures 6 and 7 give a comparison between the deflection as measured in the testing machine and that that would be obtained using values of EI as outlined in Reference 1 for the same static load. The difference can be attributed to (1) non-uniformity of specimens and (2) variation from line load in center. The loading member was one inch wide and had the same width, one-eighth inch thick sheet koroseal cemented to the faces contacting the specimen. This width of loading member caused the specimen to be restrained somewhat in the center.

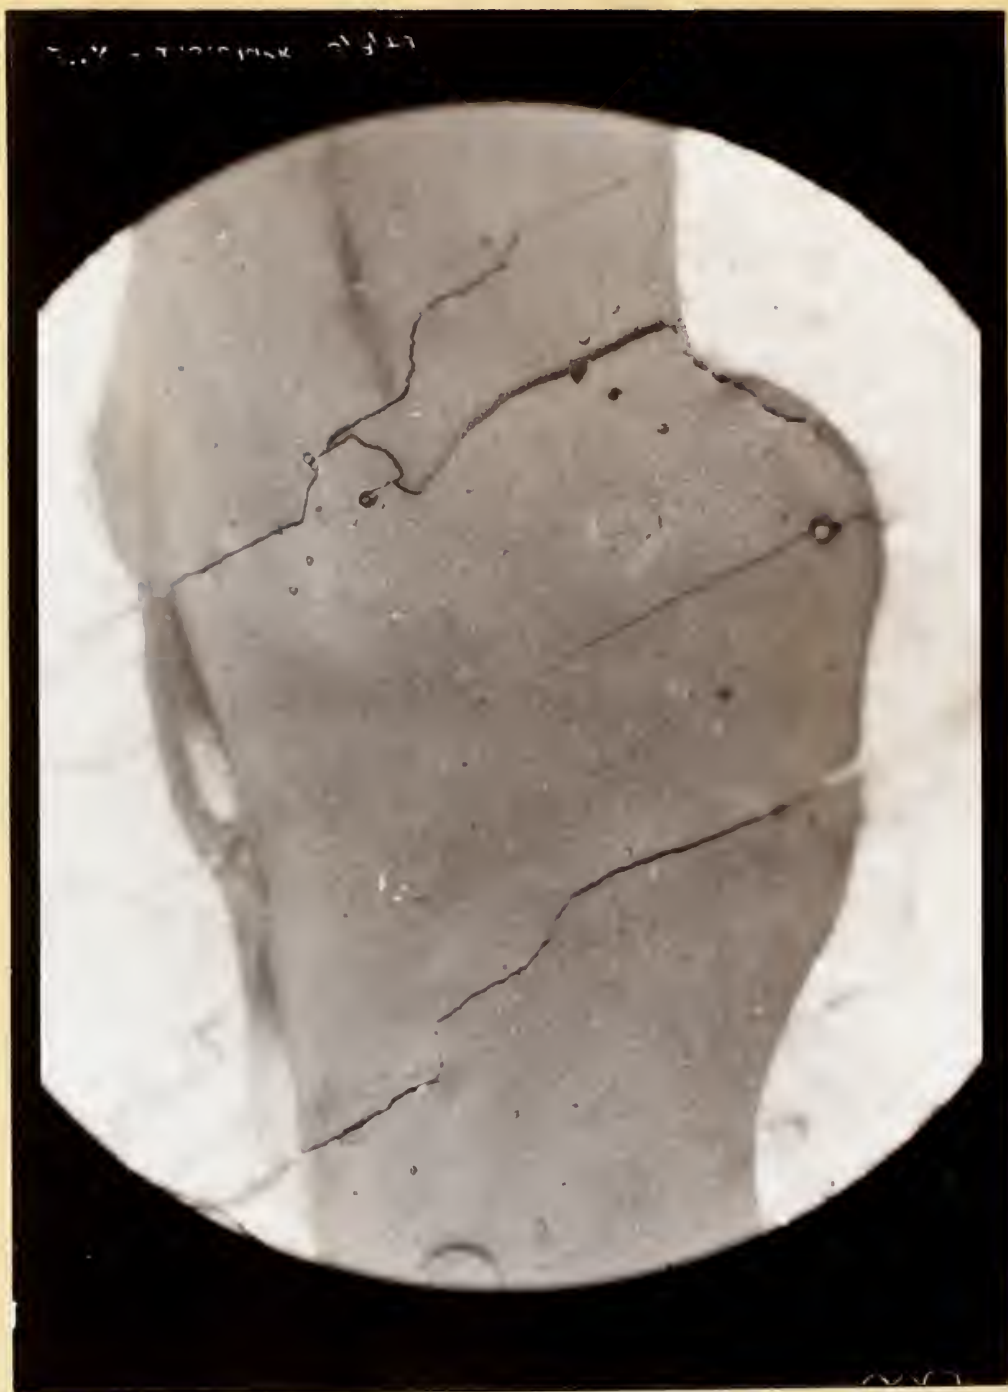
Figure 3

Photomicrograph of Crack Across Filament - Magnification 50 x

Figures 8 and 9 indicate the effectiveness of the crack detection. Figure 8 shows a crack across a saddle point with the graphite fracture ensuing. Figure 9 shows one of these cracks with the graphite and

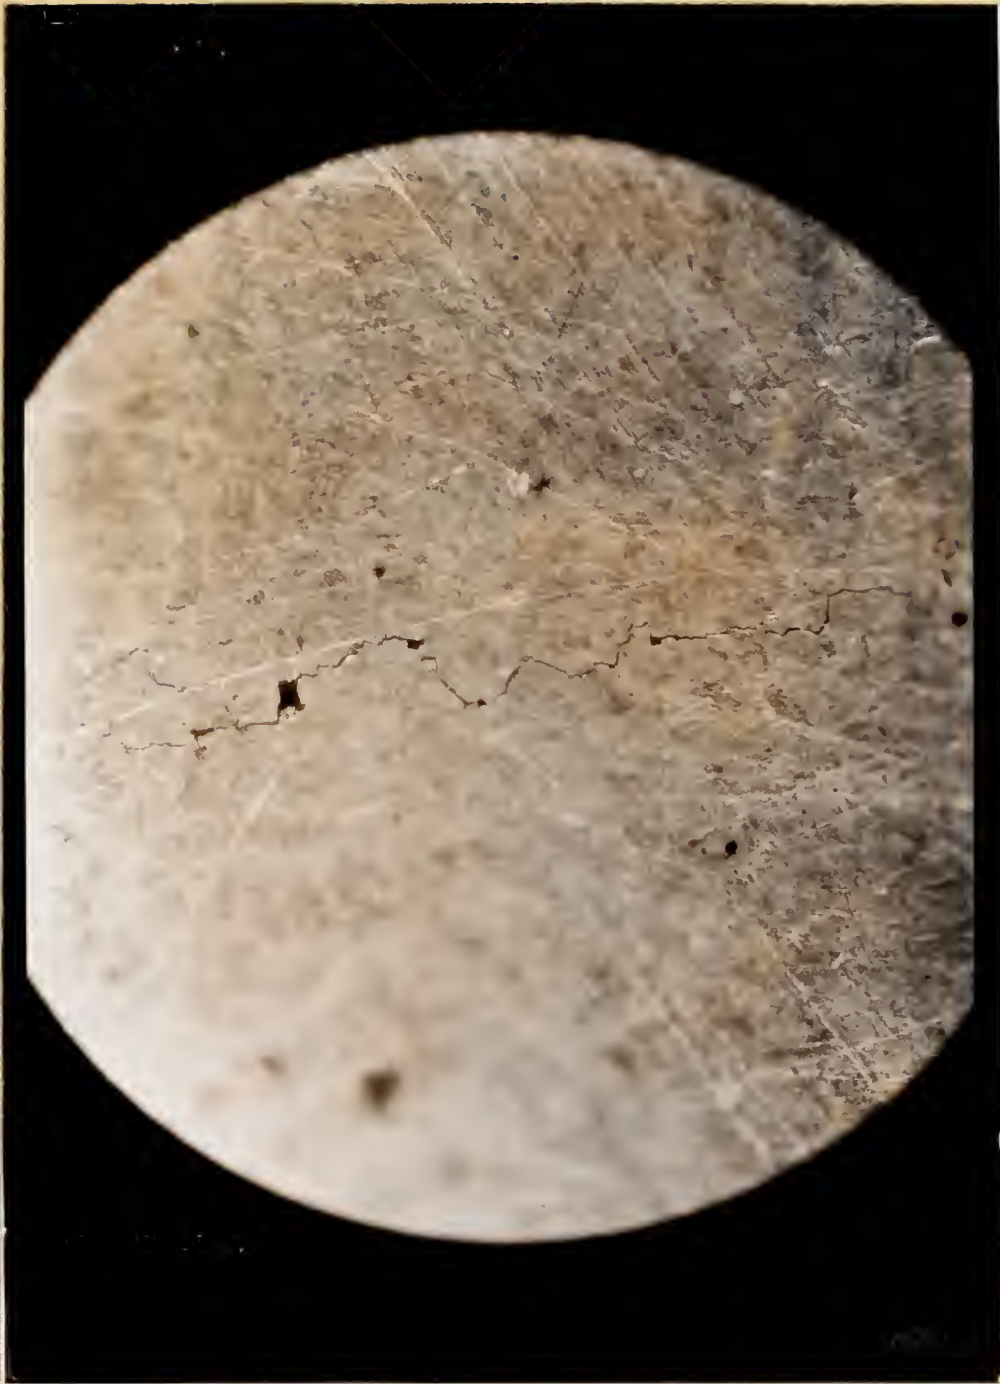
Figure 9

Photomicrograph of Crack with Filament and Cement Removed

Magnification 50 x

cerment removed. Many machine stoppages occurred with the crack causing the shut-down so fine as to be barely visible at a magnification of 40 times. It was necessary in almost all cases to utilize a resistance meter to determine in which saddle the crack occurred before the failure could be found.
